Testing and Evaluation of a Portable Workzone Sign Support: FOIL Test Numbers 98F008 and 98F009

PUBLICATION NO. FHWA-RD-98-183

DECEMBER 1998

U.S. Department of Transportation
Federal Highway Administration

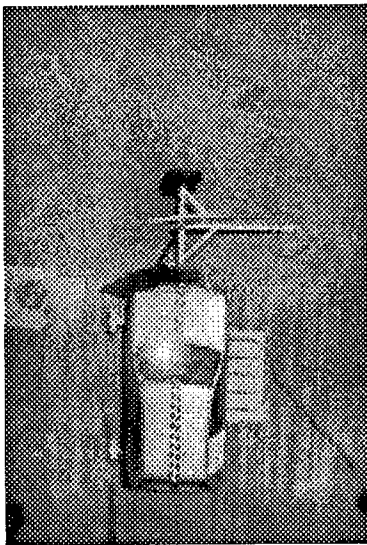
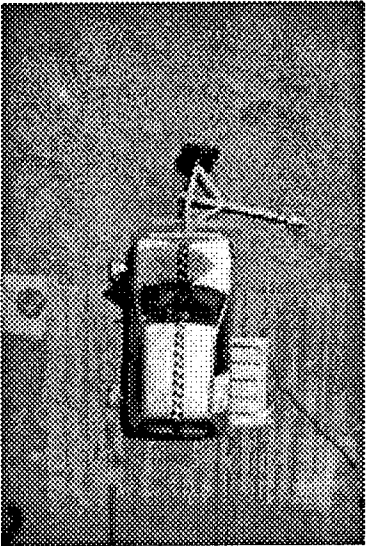
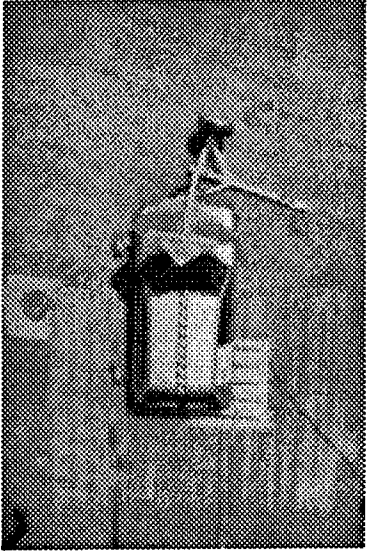
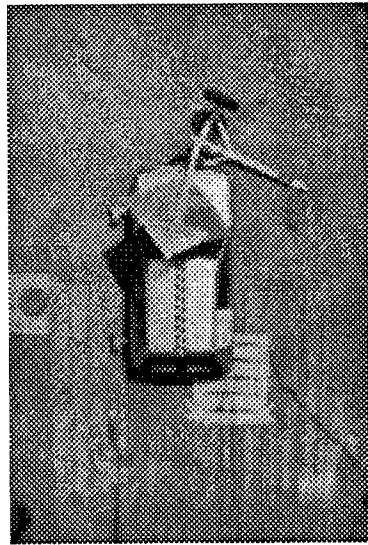
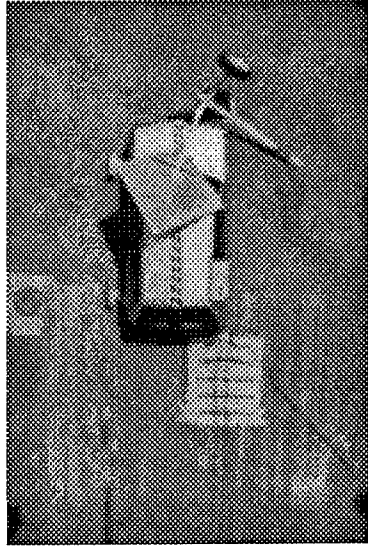
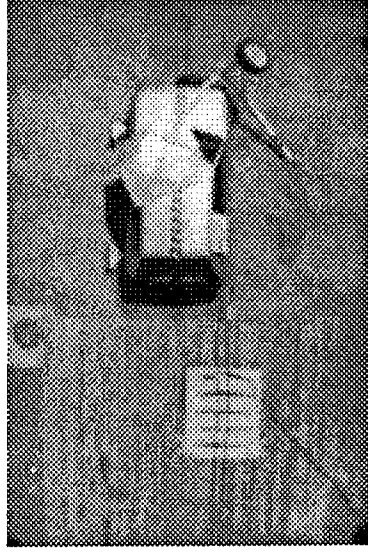
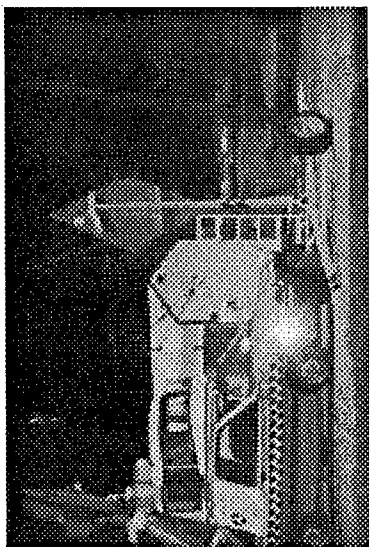
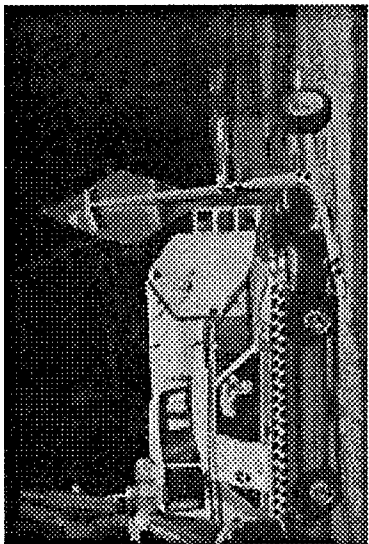
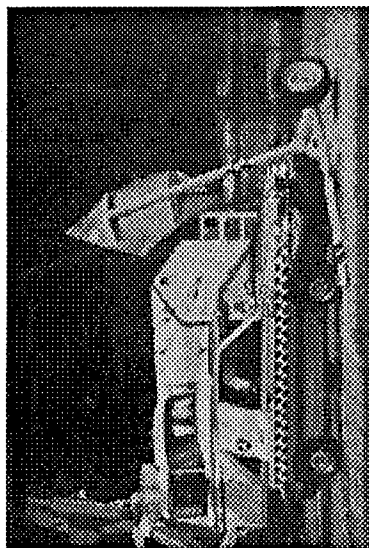
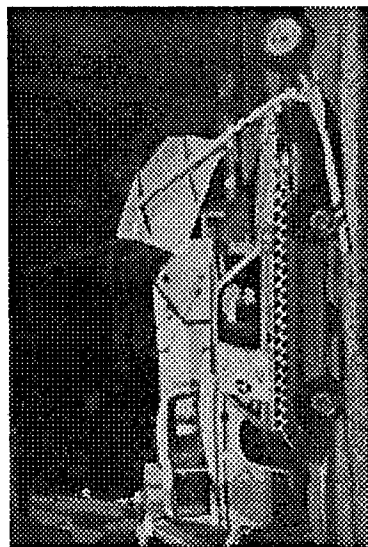
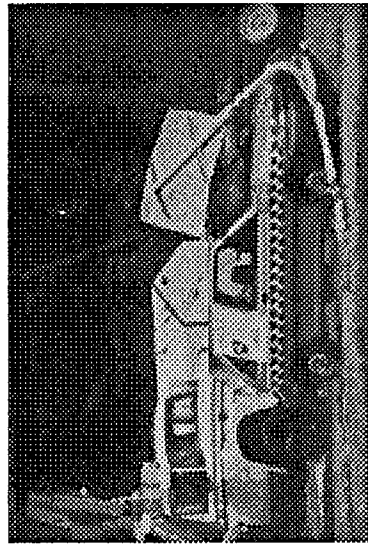
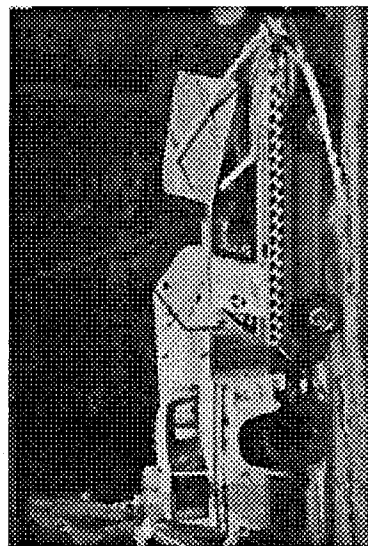
Figure 5. Test photographs during impact, test 98F008.

Test 98F008. The Ford Festiva was accelerated to 100.4 km/h prior to striking the portable sign trailer. The Ford Festiva centerline struck the sign trailer at one wheel as intended. The wheel of the sign trailer began to tuck under the vehicle and the axle began to buckle directly behind the wheel at 0.006 s. Movement of the sign trailer frame was observed at 0.010 s. The sign trailer pivoted about the end of the trailer tongue at the hitch. The struck wheel had folded over flat but remained attached to the axle by 0.054 s. The folded wheel assembly and buckled axle initiated the sign panel motion toward the windshield. The sign panel made contact with the windshield at 0.100 s. No contact between the sign post or panel and the hood was observed. As the vehicle continued to push on the end of the axle and sign panel, the sign trailer continued to rotate clockwise. The sign trailer was also being lifted by the vehicle's front end. The vehicle remained in contact with the sign trailer until approximately 0.250 s. The vehicle continued

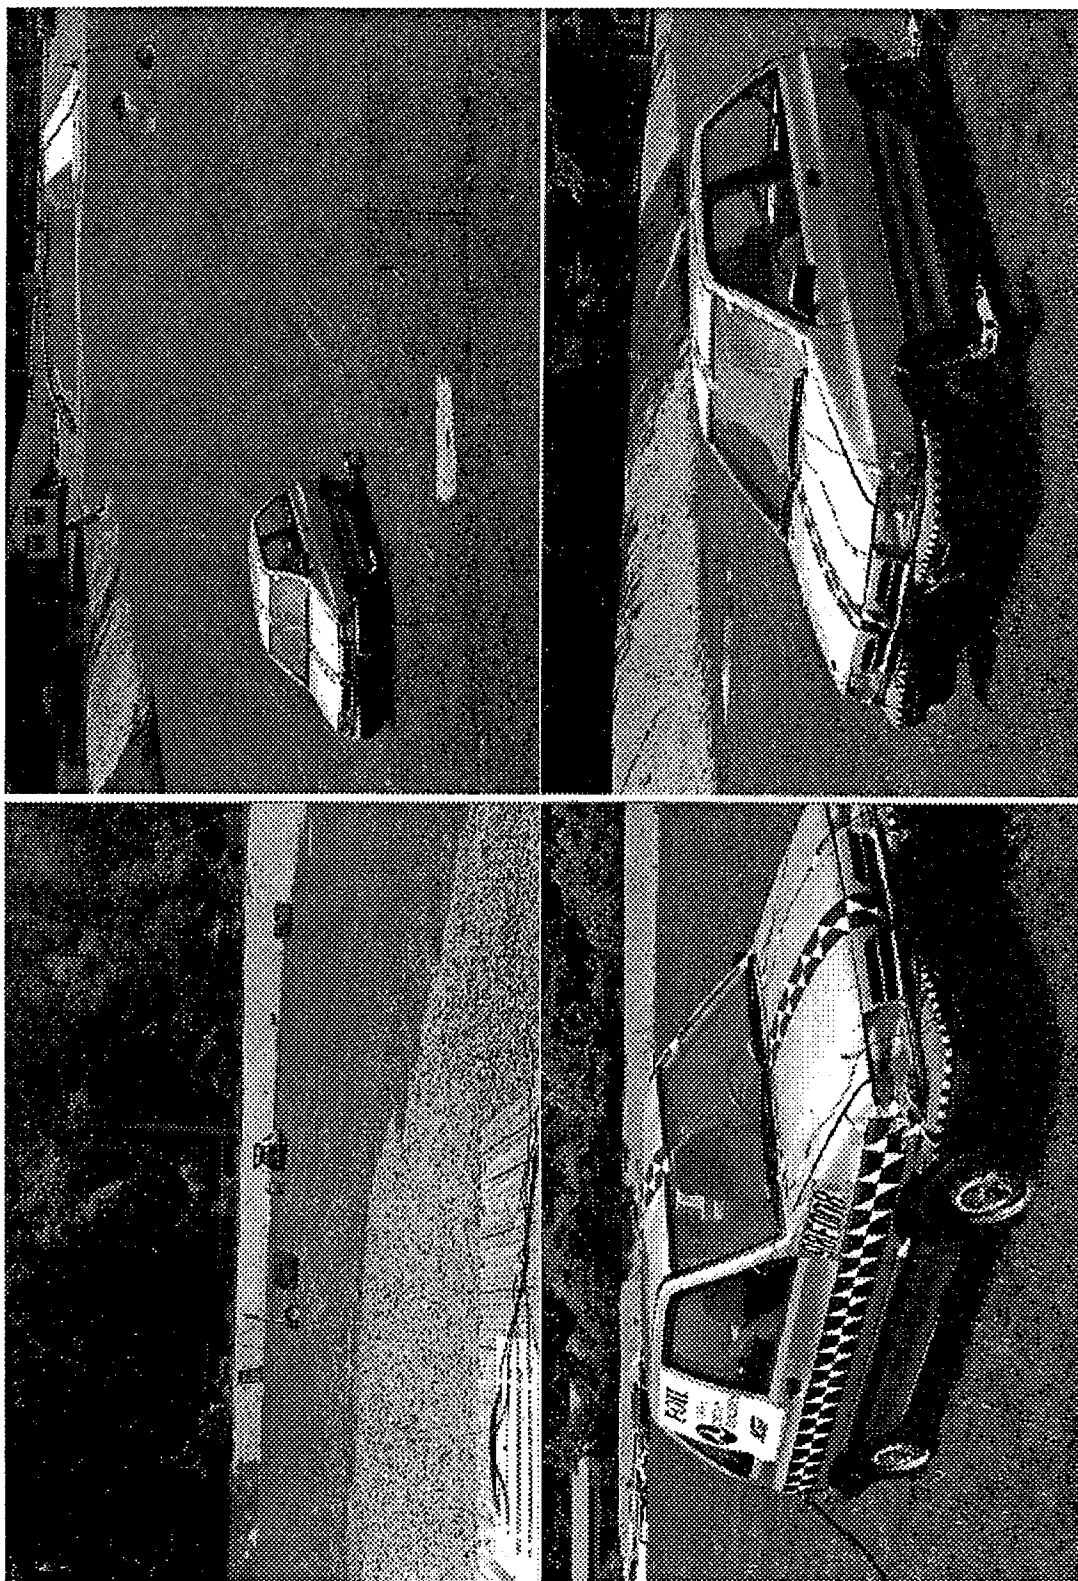
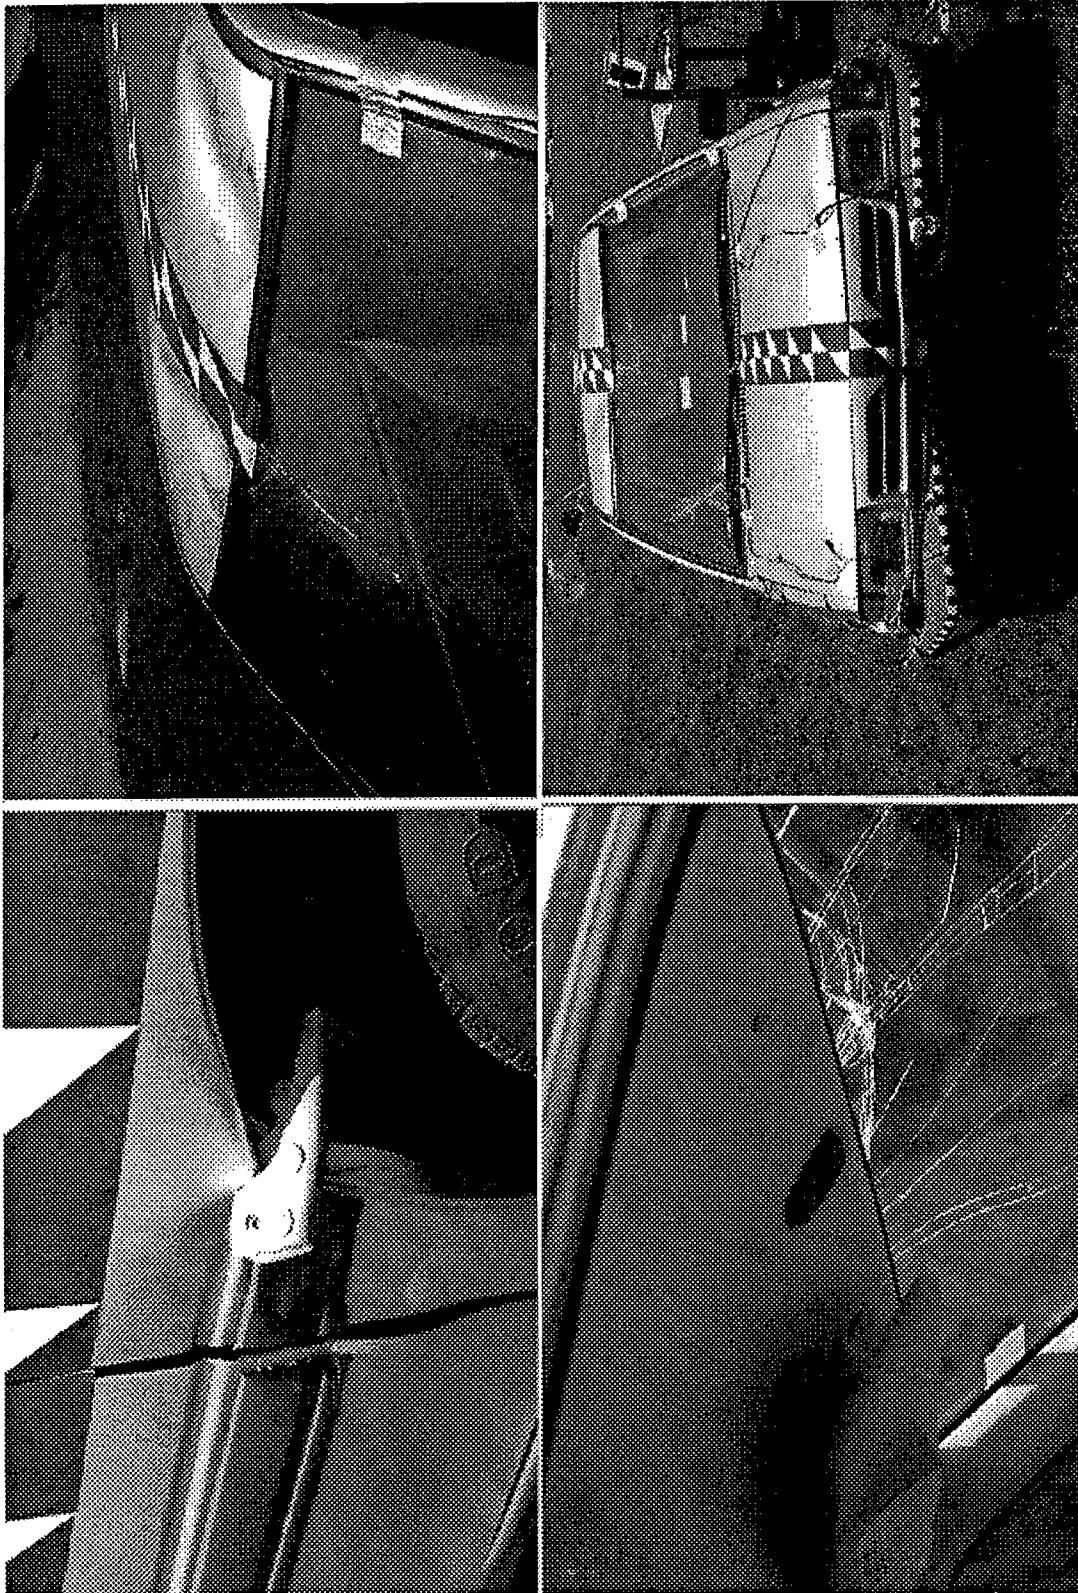
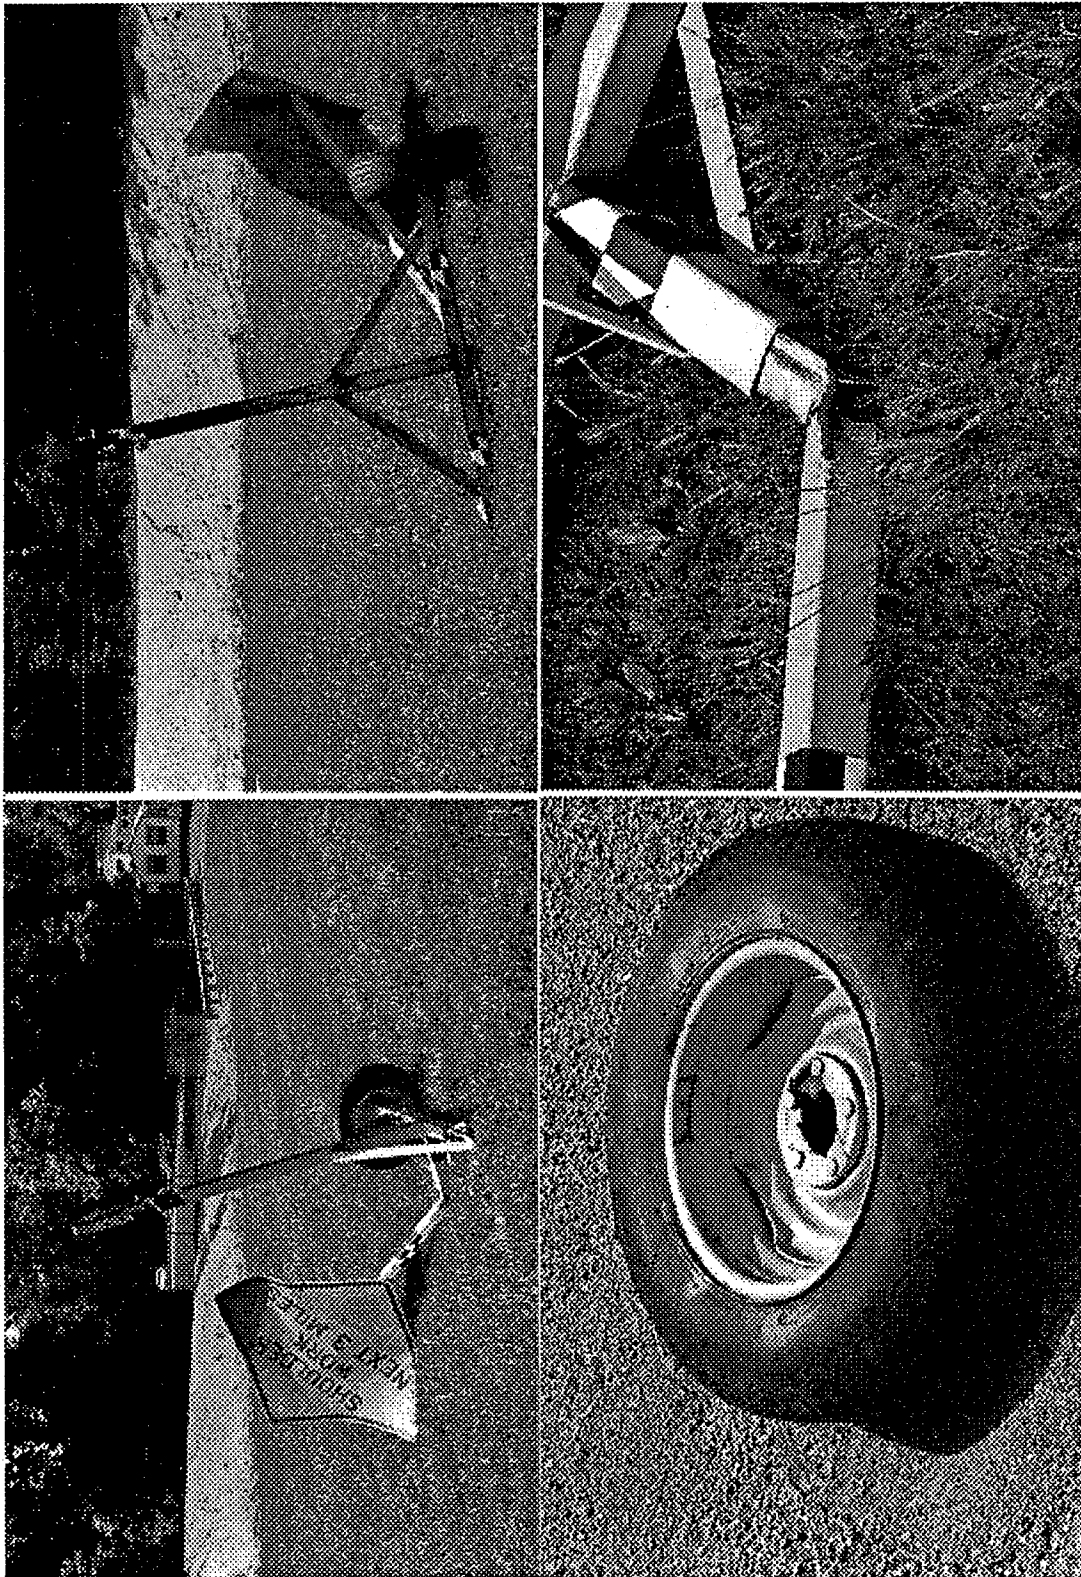
Figure 8. Post-test photographs, test 98F008.

b. Vehicle damage. Damage to the Ford Festiva consisted of minor to significant cosmetic dents to the bumper and roof. The maximum crush of the bumper was 159 mm and the roof was dented approximately 20 mm. The windshield was cracked but there was no intrusion and no loss of visibility. No debris from the test vehicle was observed in the runout path of the vehicle. The vehicle trajectory did not change after contact with the sign. No yaw was observed in the test vehicle's path. The vehicle remained stable throughout the test.

c. Test device damage. Damage to the portable sign trailer was substantial. The axle and sign post buckled severely. The sign panel remained fastened to the sign post, and the post remained inside the trailer sleeve. The sign trailer landed 49 m downrange and to the right of the test vehicle's trajectory. The struck wheel hub broke at the spindle and the tire rolled 103 m downrange. The sign trailer could not be repaired and reused without significant structural repair.

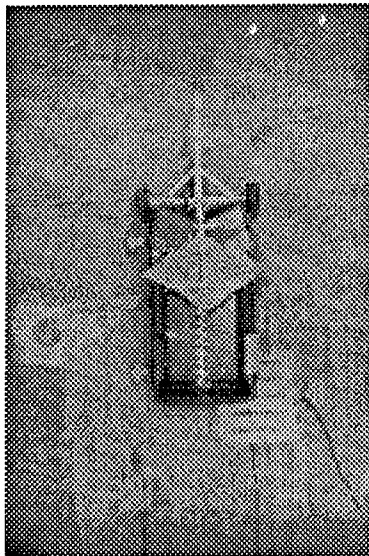
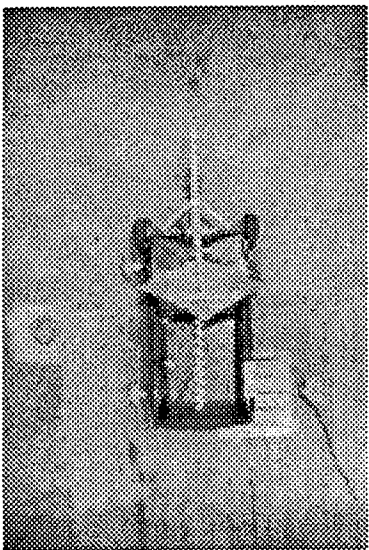
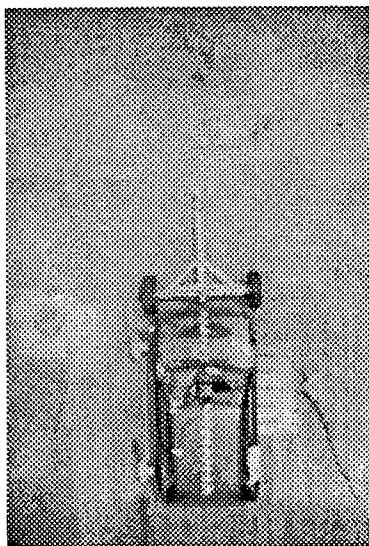
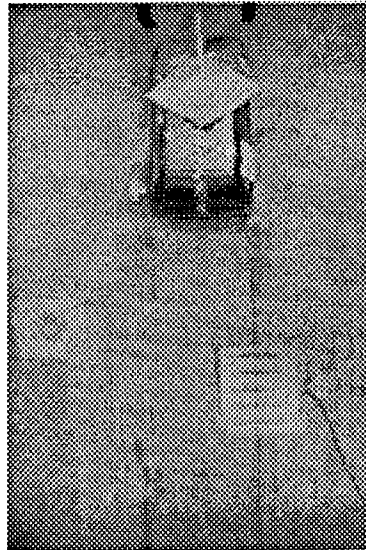
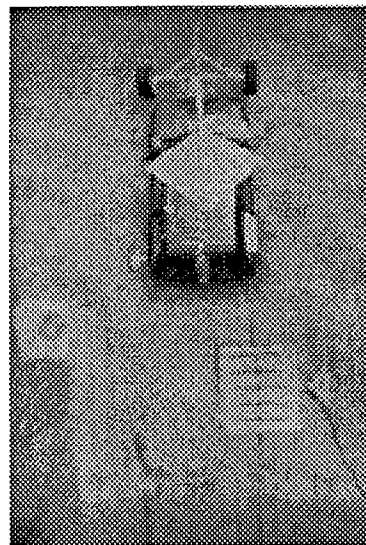
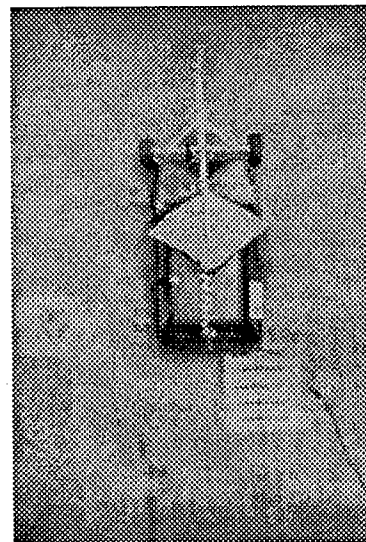
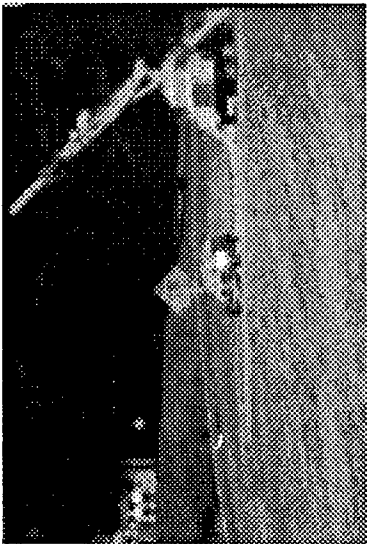
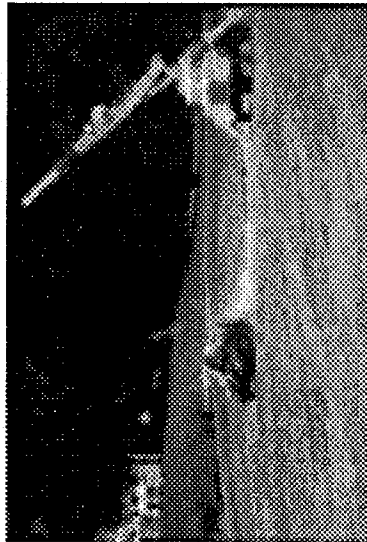
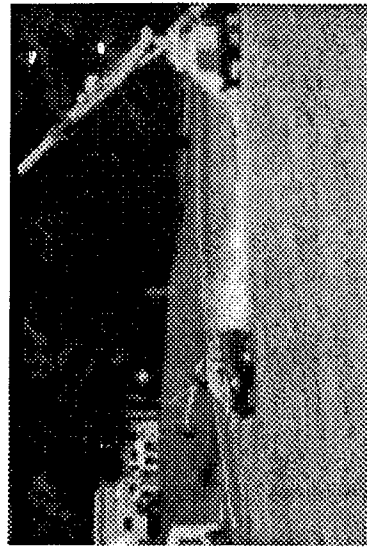
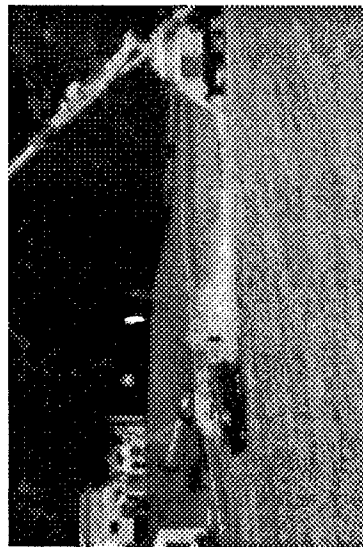
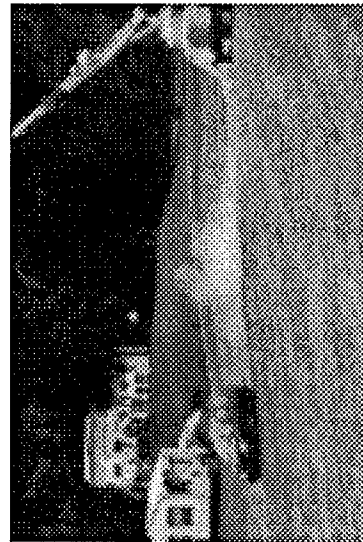
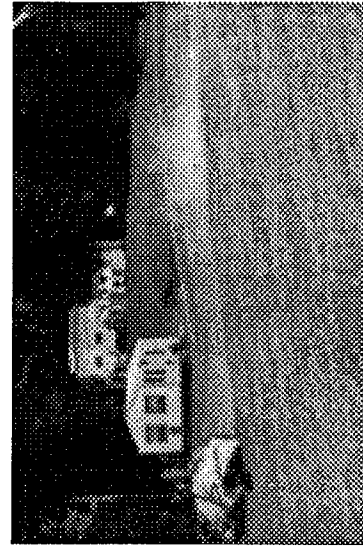
Figure 23. Test photographs during impact, test 98F009.

Test 98F009. The Ford Festiva was accelerated to 99.1 km/h prior to striking the portable sign trailer. The Ford Festiva centerline struck the sign trailer on the sign post between the trailer's two tires. The sign trailer began to move on contact and the bumper, grill, and hood had crushed significantly by 0.026 s. The vehicle bumper contacted the sign trailer 230 mm above the trailer's axle, but on the sign post sleeve (not directly on the sign post). The contact and the inertia of the tall sign post caused the sign panel and post to rotate down on top of the vehicle, striking the windshield at 0.110 s. The sign trailer's tongue and hitch pushed through the soil slightly before being rotated upward as the sign tipped toward the vehicle. The entire trailer was lifted up and rode on the hood of the vehicle before being launched upward and away from the vehicle. The maximum height of the sign trailer was approximately 2.3 m. The vehicle continued along its original line of trajectory. The sign trailer landed 75 m downrange from its original position and to the left of the vehicle's trajectory. The sign trailer remained intact, although with significant structural damage.

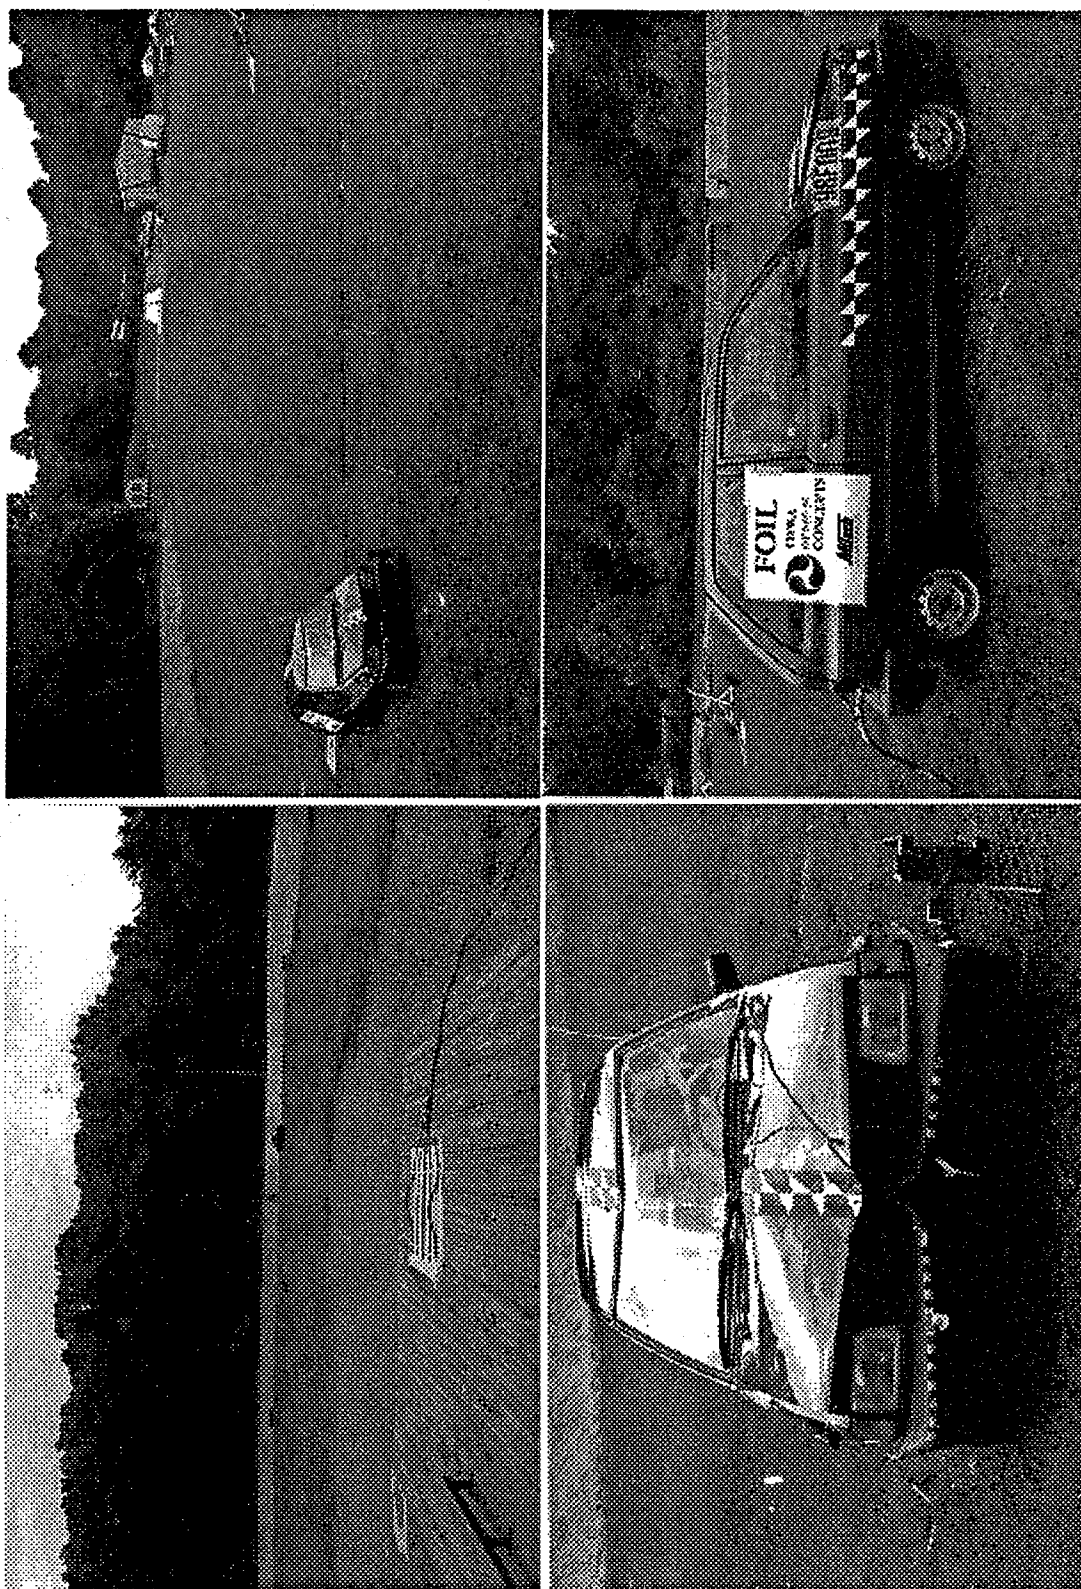
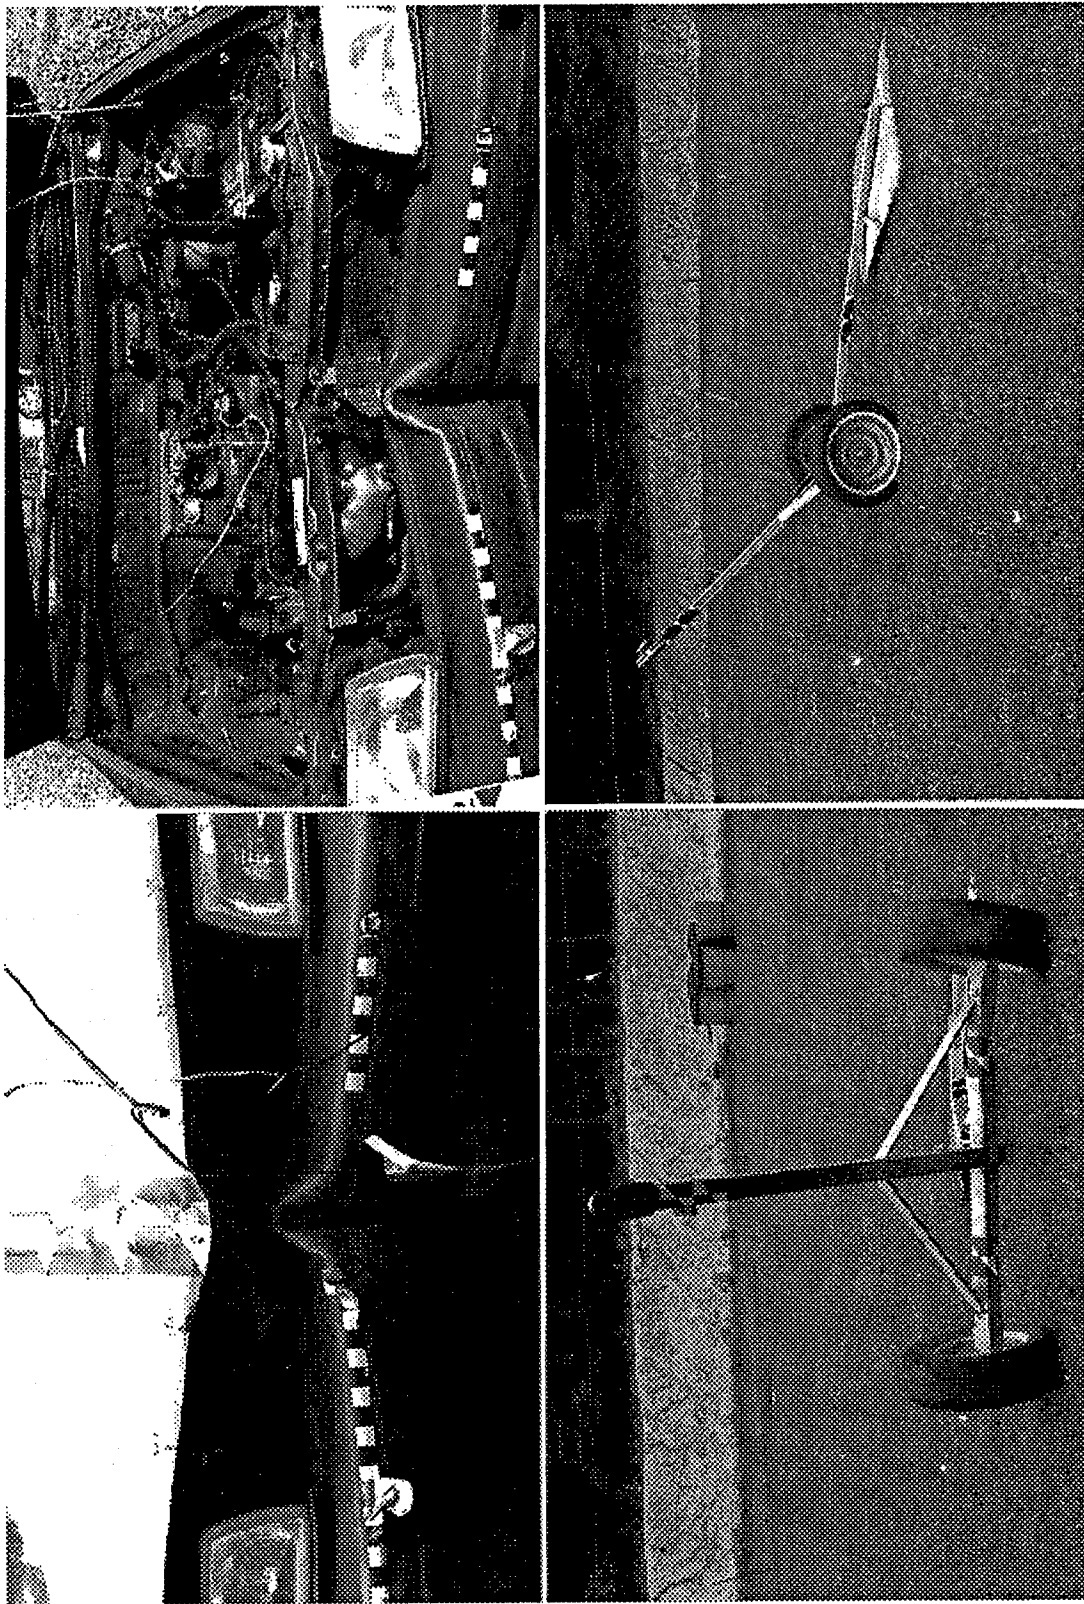
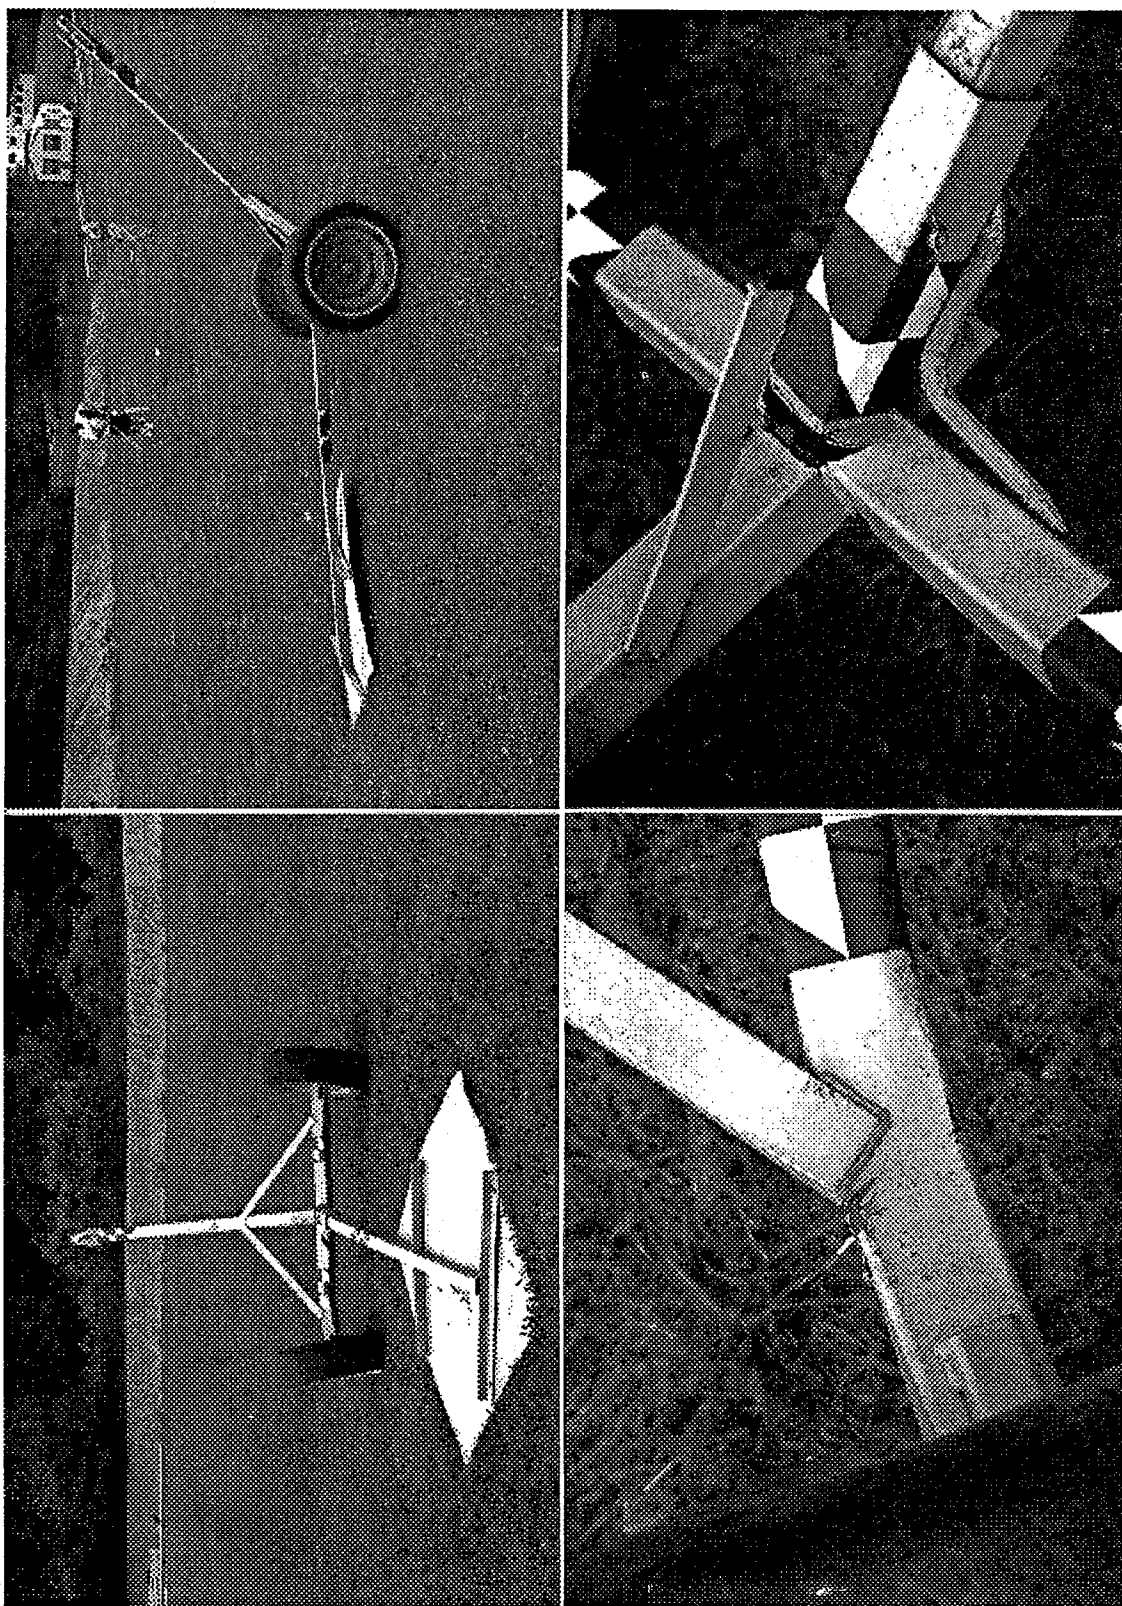
Figure 26. Post-test photographs, test 98F009.

b. Vehicle damage. Damage to the Ford Festiva consisted of minor to significant cosmetic dents and crush of the bumper, hood, and roof. The maximum crush of the bumper was 249 mm and the roof was dented approximately 50 mm. The windshield was cracked but there was no intrusion and no loss of visibility. No debris from the test vehicle was observed in the runout path of the vehicle. The vehicle trajectory did not change after contact with the sign. No yaw was observed in test vehicle's path. The vehicle remained stable throughout the test.

c. Test device damage. Damage to the portable sign trailer was substantial. The axle and sign post did not buckle, however, the base of the sign sleeve tore from the axle. Both axle/spindle connections were bent inward, causing both wheels to have severe "toe-in." The sign panel remained fastened to the sign post and the post remained inside the trailer sleeve. The sign trailer landed 75 m downrange and to the left of the test vehicle's trajectory. The sign trailer could not be repaired and reused without significant structural repair.
